DEPARTMENT OF TRANSPORTATION**DIVISION OF ENGINEERING SERVICES**

Contract #: 04-0120F4Cty: SF/ALA Rte: 80 PM: 13.2/13.9File #: 69.28**WELDING INSPECTION REPORT****Resident Engineer:** Pursell, Gary**Address:** 333 Burma Road**City:** Oakland, CA 94607**Report No:** WIR-002068**Date Inspected:** 31-Mar-2008**Project Name:** SAS Superstructure**OSM Arrival Time:** 1830**Prime Contractor:** American Bridge/Fluor Enterprises, a JV**OSM Departure Time:** 730**Contractor:** Zhenhua Port Machinery Company, Ltd (ZPMC), Changxing Island **Location:** Shanghai, China**CWI Name:** See Below**CWI Present:** Yes No**Inspected CWI report:** Yes No N/A**Rod Oven in Use:** Yes No N/A**Electrode to specification:** Yes No N/A**Weld Procedures Followed:** Yes No N/A**Qualified Welders:** Yes No N/A**Verified Joint Fit-up:** Yes No N/A**Approved Drawings:** Yes No N/A**Approved WPS:** Yes No N/A**Delayed / Cancelled:** Yes No N/A**Bridge No:** 34-0006**Component:** Tower and OBG Fabrication**Summary of Items Observed:**

Orthotropic Box Girder (OBG) and Tower Fabrication:

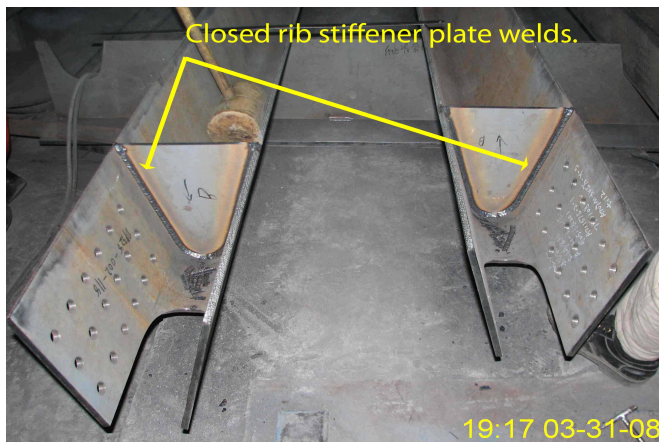
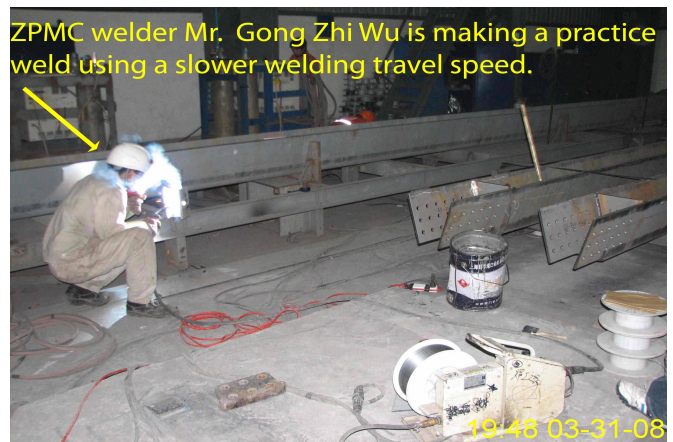
The QA Inspector observed ZPMC welder Mr. Gong Zhi Wu, stencil 59405 is using welding procedure specification WPS-B-T-2133 to make a flux cored fillet weld on OBG deck plate closed rib stiffener plate weld DP328-001-118. The QA Inspector observed a welding current of approximately 220 amps and 25.0 volts. The QA Inspector observed Mr. Wu has a welding travel speed of approximately 165 mm per minute. The welding procedure specification states the maximum welding travel speed is 124 mm per minute and Mr. Wu appears to have an excessive welding travel speed. A review of QC Inspector Mr. Wang Xiang Pon welding document shows the QC welding data sheet lists Mr. Wu has a maximum welding travel speed of 120 mm per minute. The QA Inspector asked QC Inspector Mr. Pon and CWI Mr. Chen Xi to confirm the welding travel speed that is being used by Mr. Wu. Mr. Xi had ZPMC welder Mr. Wu make a practice fillet weld on a scrap of material to ascertain what welding travel speed was being used and after the weld was completed Mr. Xi said Mr. Wu is welding slightly above the maximum welding travel speed that is listed in the WPS. Prior to conducting a second weld on a scrap of plate, Mr. Xi had the welding machine current and voltage decreased to near the minimum levels as listed in the WPS. Mr. Wu then made a second practice weld and the welding travel speed was within an acceptable range as listed in the WPS. Later in the shift the QA Inspector observed Mr. Wu has a welding current of 200 amps, 23.9 volts and a welding travel speed of approximately 115 mm per minute, which complies with the travel speed that is listed in the welding procedure specification. See the photograph below for additional information.
